Bramley ProBender 35t Powered Bender

Service Manual Section

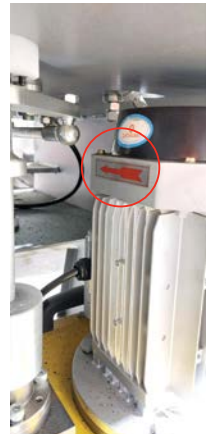
Remove the back cover. Check the motor is running in the clockwise direction as indicated by the arrow on the motor cowling.

If the motor is not running in the correct direction, 2 of the 3 phases will need to be swapped to achieve correct rotation.

The hydraulic motor must run in the clockwise direction.

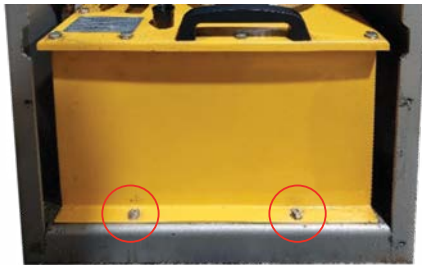
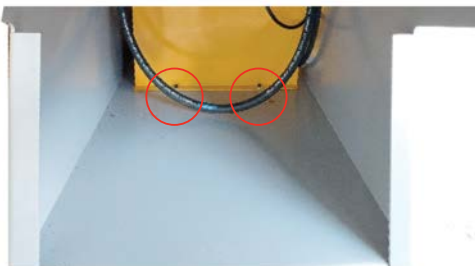
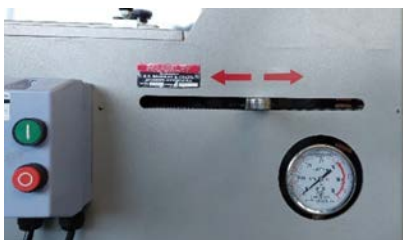
Hydraulic unit alignment

Loosen the 4x m6 cap screws on the base of the hydraulic unit. Move the hydraulic unit until the handle shaft / lever assembly moves evenly through the slot in the machine body.

Retighten 4 x m6 cap screws.

Control lever does not move freely backwards or forwards or no reverse or forward movement possible.	Hydraulic unit has shifted in transit.	Re align hydraulic unit. Remove rear panel. Loosen 4 x m6 cap screws on the base of the hydraulic unit. Move hydraulic unit until handle shaft assembly moves evenly in slot in front of machine. Retighten 4 x m6 cap screws. See section 3. (Hydraulic unit alignment).
The maximum working pressure is above or below 4000PSI/28MPa	For safety reasons the maximum working pressure must not exceed 4000PSI/28MPa	The high-pressure low volume controlling valve requires adjusting (LH valve when viewed from the rear, rear cover removed) THIS IS FACTORY SET. See section 4. (Pressure setting).
Oil leaking from hose connections from hydraulic unit to ram.	Check hydraulic hose quick connections.	The ProBender uses quick connectors between the hydraulic unit and the ram. Check the outer barrel is tightened as these may have worked loose. If there is oil leakage from these connections after tightening, the connectors o-ring or the o-ring backer needs replacing.

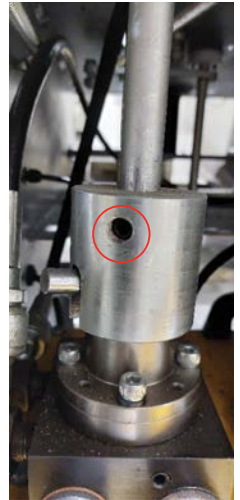
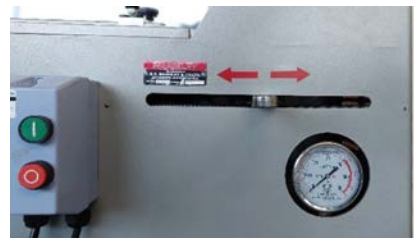
Handle lever location

The handle lever assembly is fastened to a boss cap located on top of the valve body.

The handle should be centrally located and after being moved forward or backward, should return back centrally.

The hydraulic valve must be returned to its central neutral detent in this central position.

There is a m12 grub screw on the boss cap. Loosen this, rotate the valve forward and back until the central detent is located. Check the control lever is in the centre of its slot in front of machine.

Retighten grub screw and check movement.

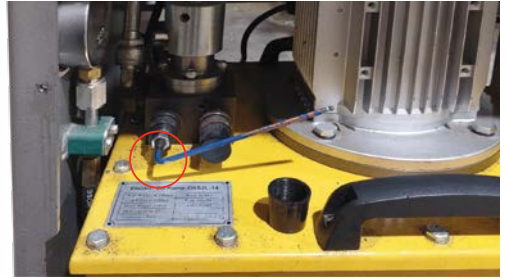
The hydraulic unit fitted to the ProBender is a dual pump 2 speed unit. It uses a high-volume low-pressure pump controlled by the valve on the right (shown in the pic overpage with a plastic cap on it).

DO NOT ADJUST THIS RIGHT HAND VALVE.
 Adjusting this valve will have no impact on the gauge pressure setting as it controls the **high-volume low-pressure** pump. This cuts out and hands over to high pressure side when this valve is tripped. **DAMAGE CAN BE CAUSED BY INCORRECTLY SETTING THIS VALVE TOO LOW.**

The left-hand valve (*shown here fitted with an allen key inserted*) controls the high-pressure low-volume pump.

To set the maximum working pressure, remove the plastic cap, loosen the lock nut and fit the allen key as shown.

Momentarily bring the unit up to pressure by feeding V former against the mandrel. Adjustments are small. Half a turn to a turn max should be all that is required. Turning counter clockwise will reduce pressure. Adjust to 4000 PSI/28 MPa.
